Manhole Inspection Summary

Manhole # S39AA_016MH

Insp Date: **11/27/07 2:59 PM**

Location Address: **ajax alley**

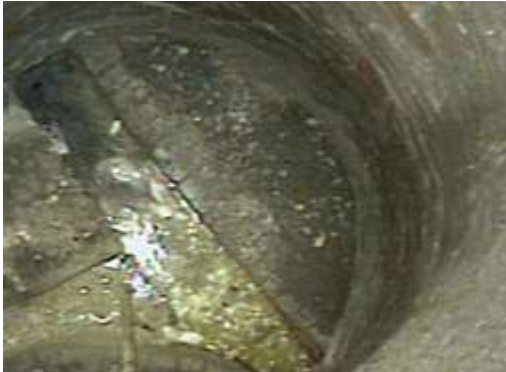
Defect 3

Condition: ☐ Sound ☐ Cracked ☐ Root Intrusion ☐ Deteriorated ☐ Leaks ☒ **Debris**

bench debris

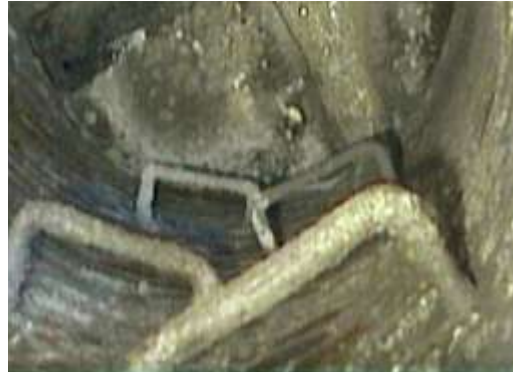
Defect 2

Count: **4** Missing: **0** ☒ **Corroded**

steps

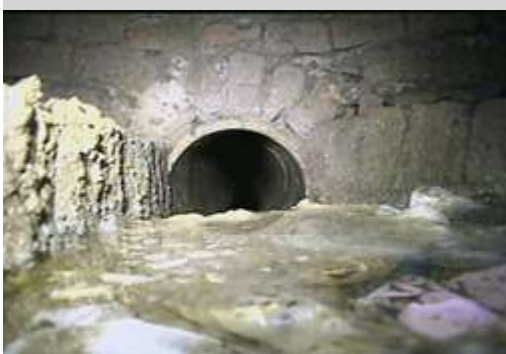
Defect 1

Condition: ☐ Sound ☐ Cracked ☐ Root Intrusion ☐ Deteriorated ☐ Leaks ☒ **Debris**

channel debris

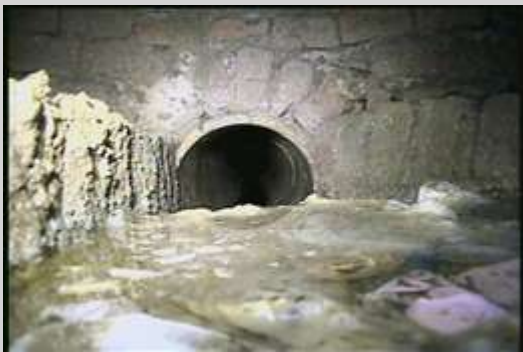
12 O'Clock Outflow

8 in. Circular Gravity Sewer
Pipe Out @ 12 O'Clock

Invert Depth: **8.75** (ft.) Flow Characteristics: **Slow**

Deposits: ☐ None ☐ Mud ☒ Sludge ☒ Debris ☐ Grease

Silt Depth: **3** (in.) Deposits Extent: **Medium**

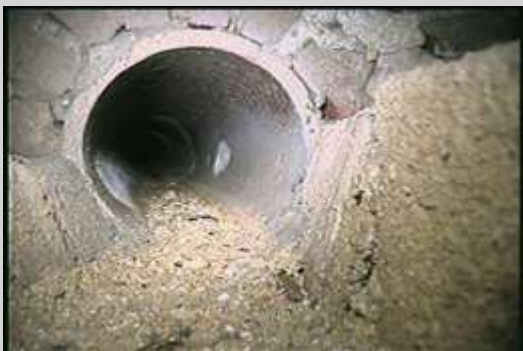
3 O'Clock Inflow

8 in. Circular Gravity Sewer
Pipe In @ 3 O'Clock

Invert Depth: **8.60** (ft.) Flow Characteristics: **Slow**

Deposits: ☐ None ☐ Mud ☐ Sludge ☒ Debris ☐ Grease

Silt Depth: **1** (in.) Deposits Extent: **Light**

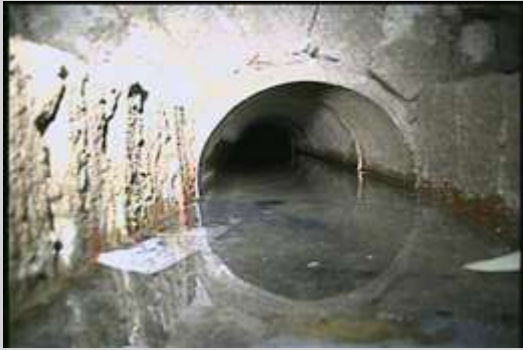
6 O'Clock Inflow

8 in. Circular Gravity Sewer
Pipe In @ 6 O'Clock

Invert Depth: **8.60** (ft.) Flow Characteristics: **Slow**

Deposits: ☒ None ☐ Mud ☐ Sludge ☐ Debris ☐ Grease

Silt Depth: **3** (in.) Deposits Extent: **Medium**
